**EVALUATION STUDY OF FIBERMAT® TYPEB  
INTERLAYER SYSTEM FOR ROADWAY PAVEMENT  
REHABILITATION**

*Original report prepared by*  
**Ghassan R. Chehab, Ph.D.**  
Assistant Professor  
&  
**Carlos J. Palacios**  
Graduate Research Assistant

Pennsylvania Transportation Institute  
The Pennsylvania State University

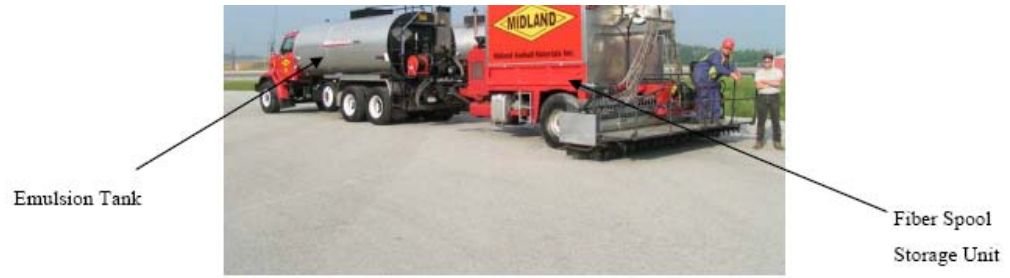
Figure 2: Truck with an emulsion tank and Fiber Storage Unit

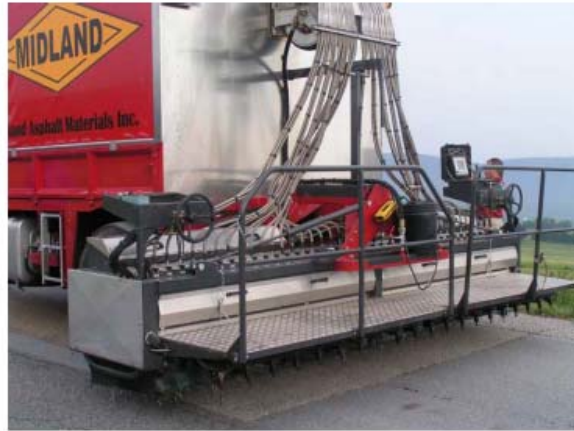
Figure 3: Rows of nozzles spraying the emulsion and fibers

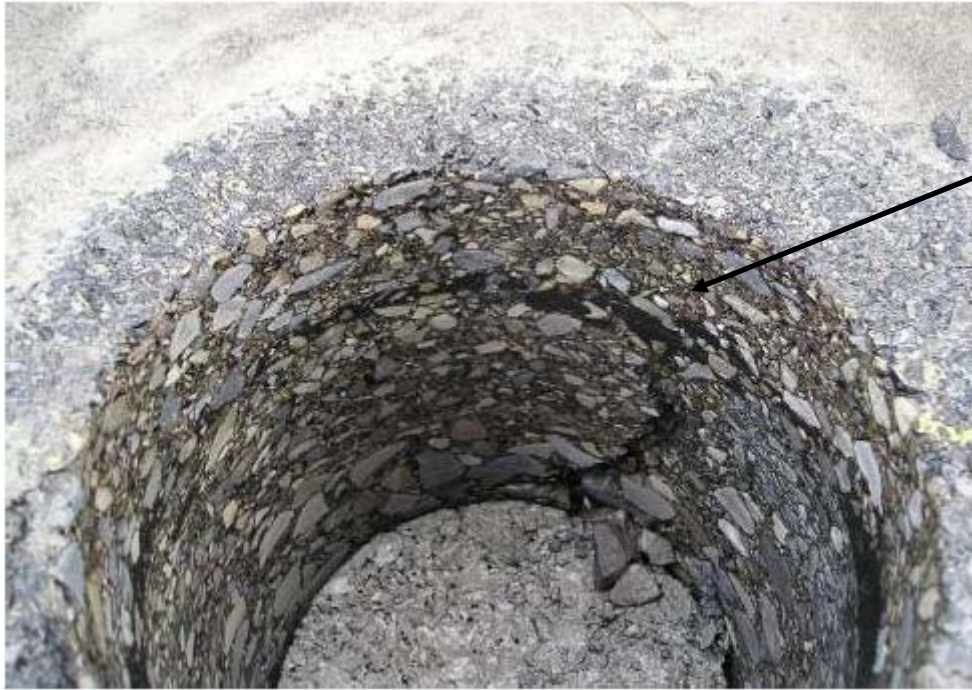
FiberMat® Type B Interlayer

Field cores were taken from the FiberMat B® experimental and control sections. Three cores were taken from locations that did not originally exhibit any cracks. From the cores it was possible to distinguish the different layers thicknesses of both FiberMat B® and the control section. An additional set of two cores were extracted on top of similar cracks in the pre-existing pavement. No reflective crack was visible on the core removed from FiberMat® Type B. For the control section, a preexisting crack could be seen

- BBR results suggest a higher ductility at lower temperature for the FiberMat® Type B interlayer which would delay cracks reflecting upwards.
- Cores removed from both sections having pre-existing cracks show that reflective cracks occur in the control section; whereas, reflective cracks are absent in the FiberMat® Type B sections.

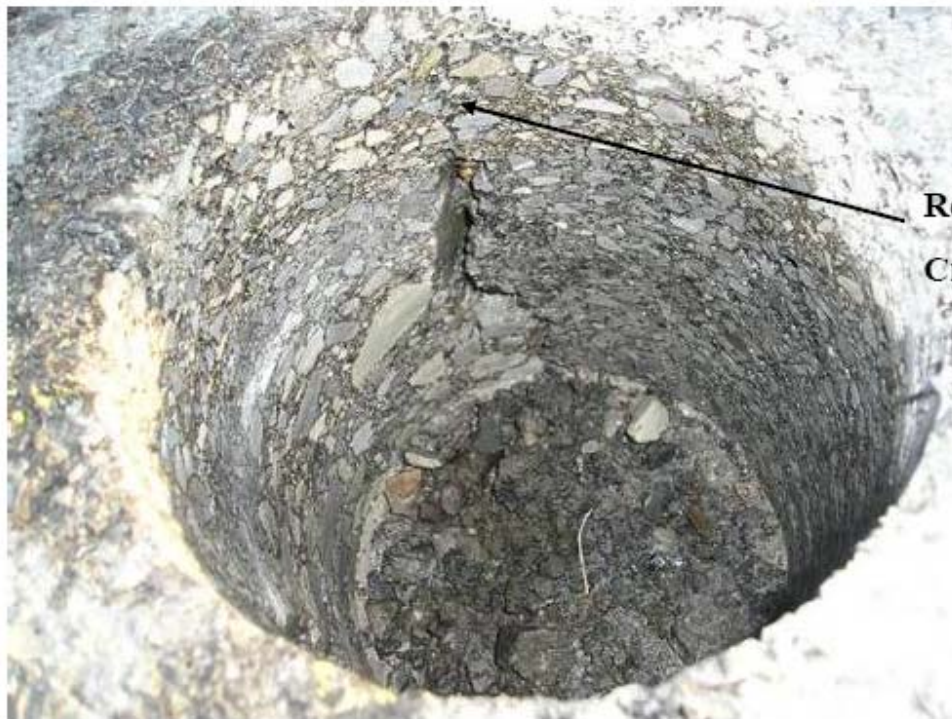
Control Section

propagating through the new overlay upwards to the surface, thus developing a reflective crack.

Reflective  
Crack
